# Mobile Pentium® II Processor Specification Update

Release Date: December 1999

Order Number: 243887-016

The Mobile Pentium® II processor or the Intel® Pentium® II Processor Mobile Module may contain design defects or errors known as errata which may cause the product to deviate from published specifications. Current characterized errata are documented in this Specification Update.

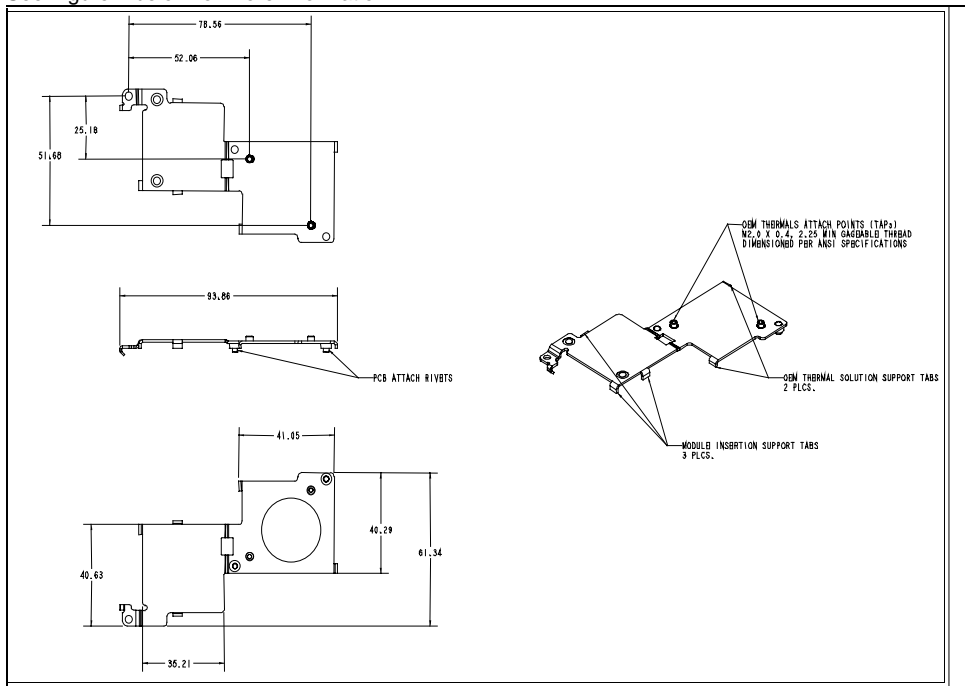
Figure 1. TAP Gageable Thread Clarification

OEM Thermal Attach Points (TAPs) M2.0 x 0.4, 2.25 min gageable thread dimensioned per ANSI specification.

See Figure 1 below for more information.
